**City of Los Angeles
WATERSHED PROTECTION DIVISION
ENVIRONMENTAL ENFORCEMENT & EMERGENCY RESPONSE UNIT**

CASE #52967

Sunday, March 17, 2019

Spill/Fire Investigation

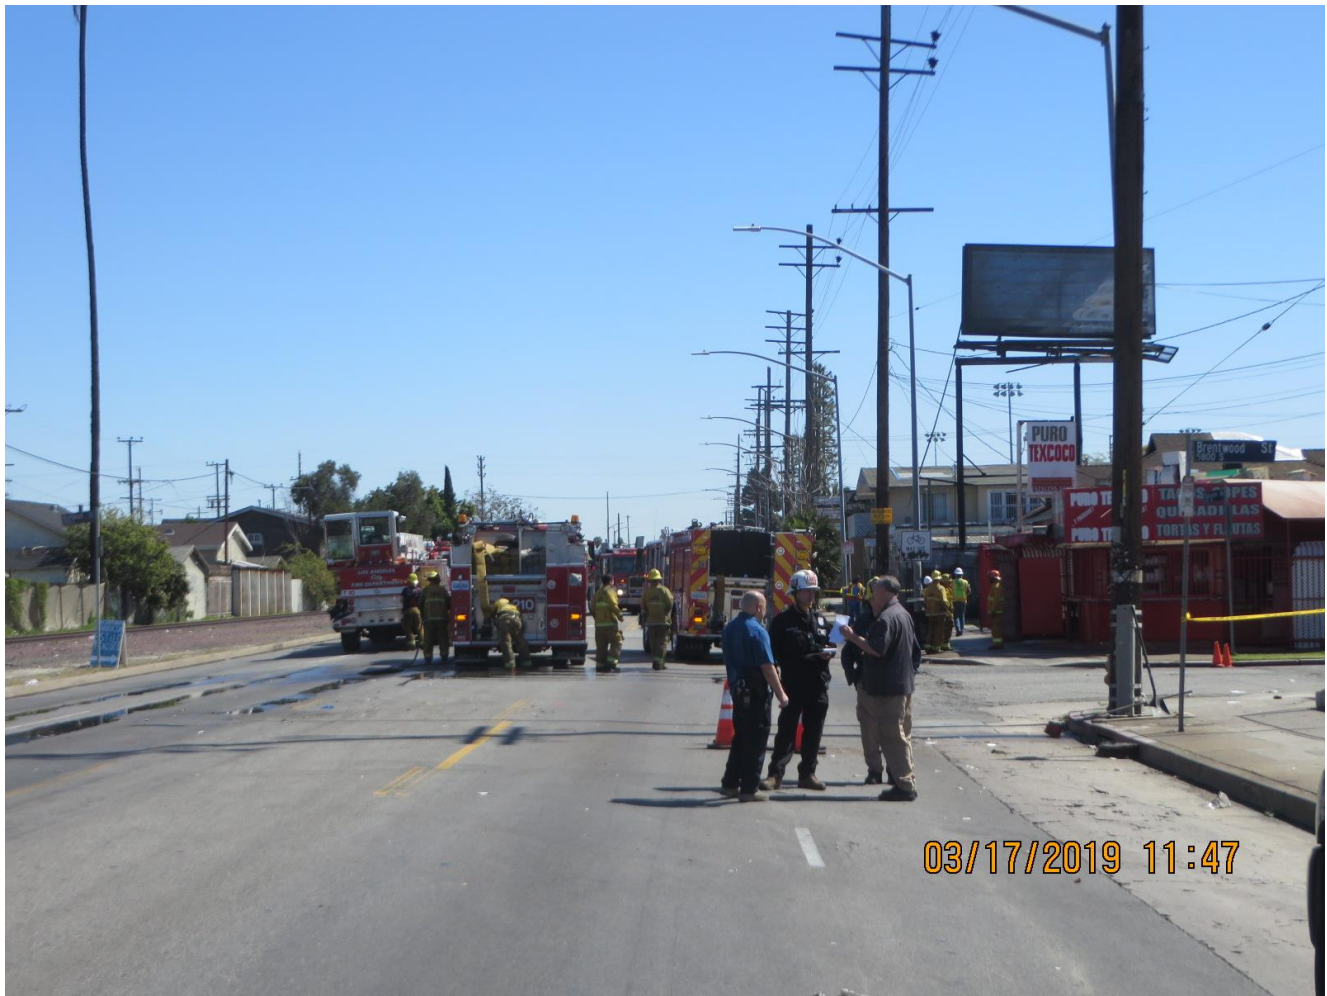
Figure #7.

View facing east on Slauson Ave; scene of incident upon WPD's arrival. Incident location (210 W Slauson Ave) east of pictured red taco building, under the billboard.

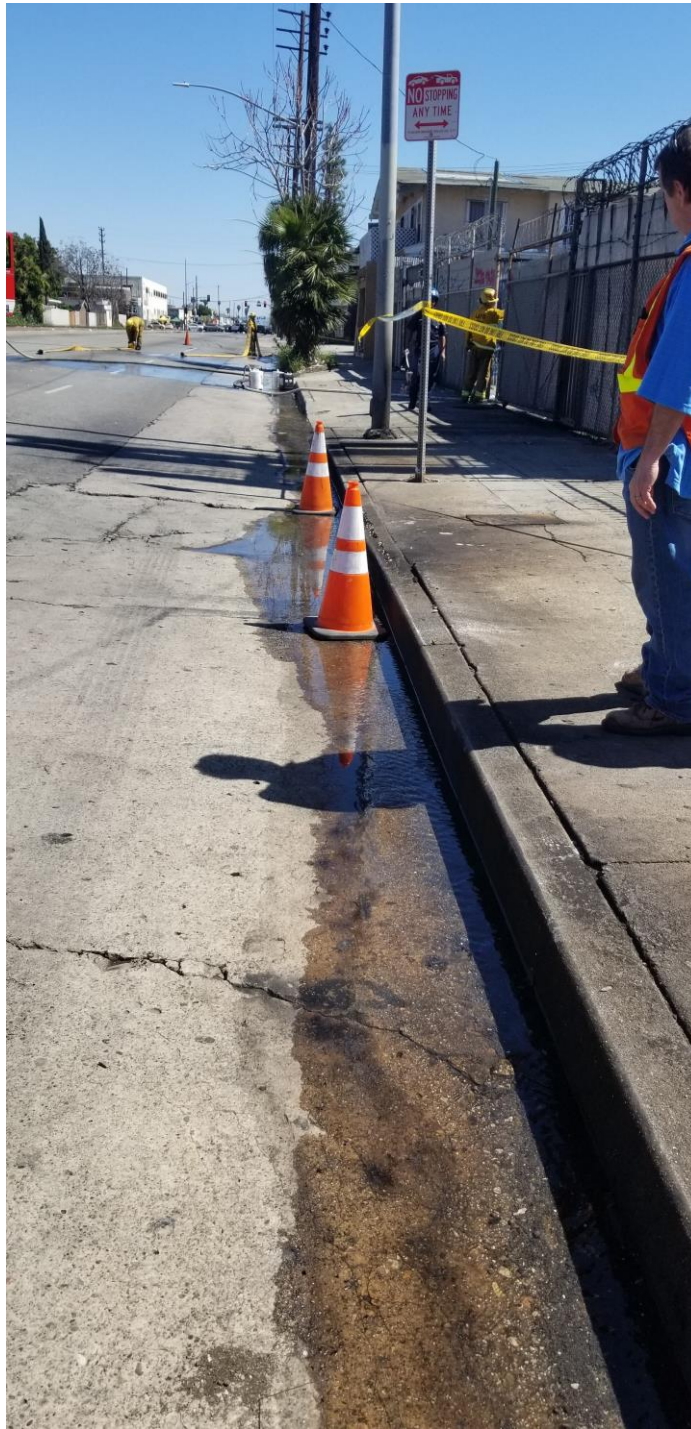
Figure #8.

View facing east on Slauson Ave; scene of incident upon WPD's arrival. Fuel & water mixture along public curb. Incident location (210 W Slauson Ave) is behind pictured LAFD firefighter.

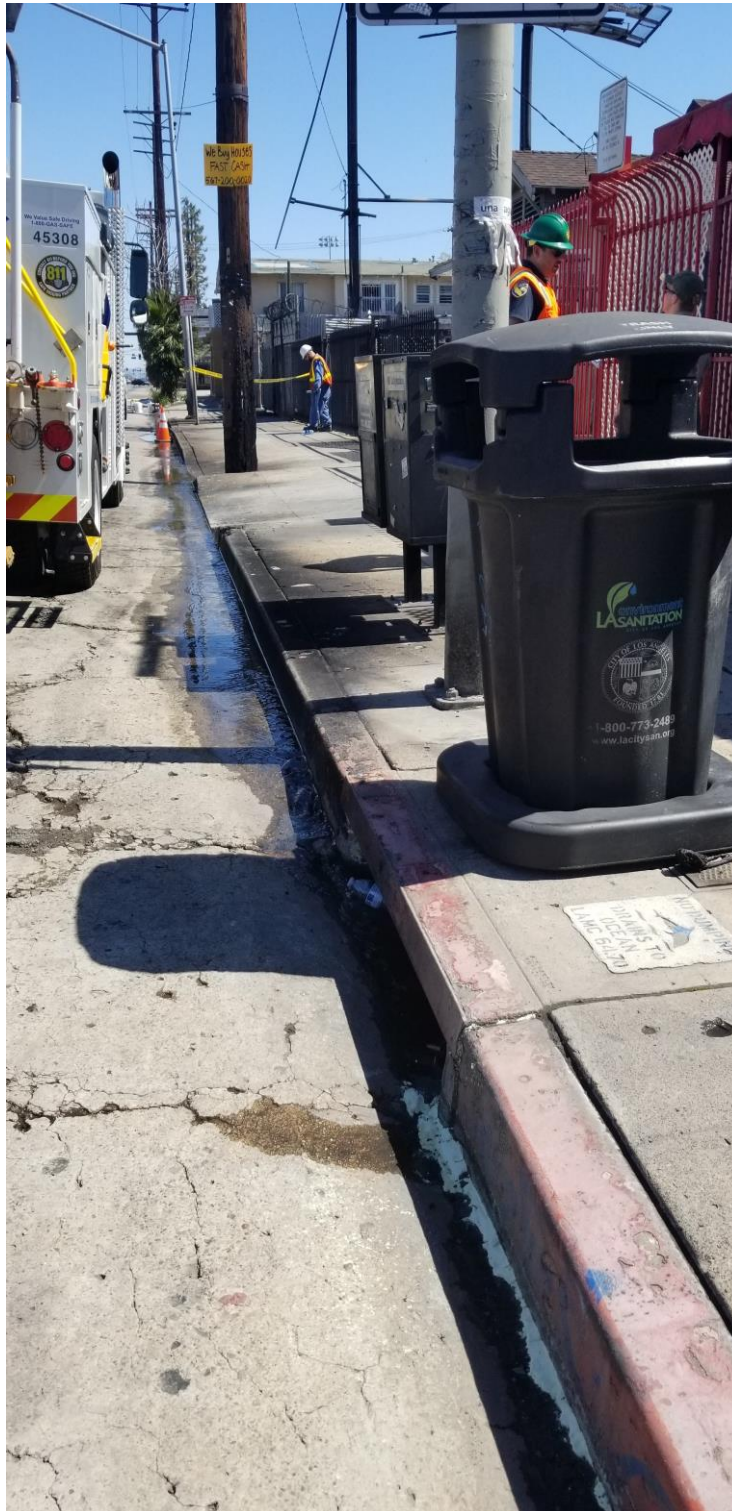
Figure #9.

View facing east on Slauson Ave; scene of incident upon WPD's arrival. Fuel & water mixture along public curb discharging into storm drain catch basin ##55701461111100. Incident location (210 W Slauson Ave) is adjacent to pictured yellow caution tape.

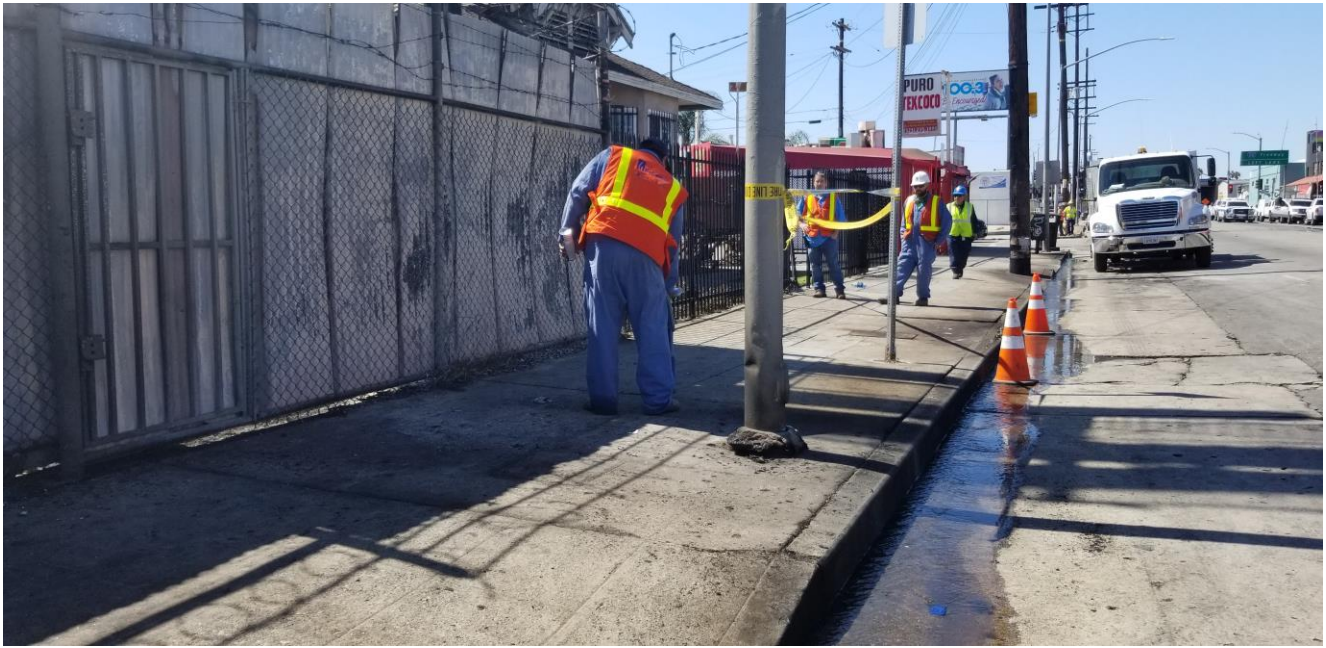
Figure #10.

View facing west on Slauson Ave. Fuel & water mixture along public curb. Incident location (210 W Slauson Ave) is behind pictured metal fencing.

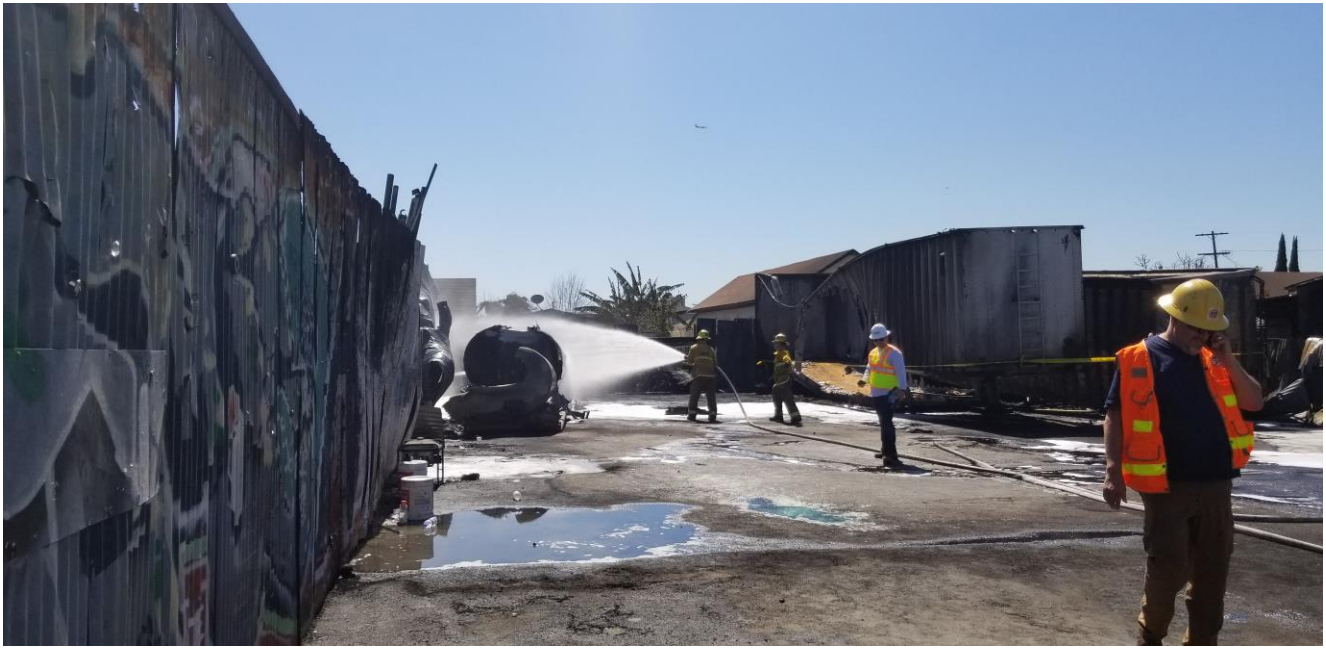
Figure #11.

View facing south at incident location 210 W Slauson Ave, Parcel A, with LAFD firefighter hosing down fire-damaged “tanker” full of fuel. Ground pooling is likely a mixture of fuel, water and fire retardant. Also pictured: fire-damaged fencing and fire-damaged trailer.

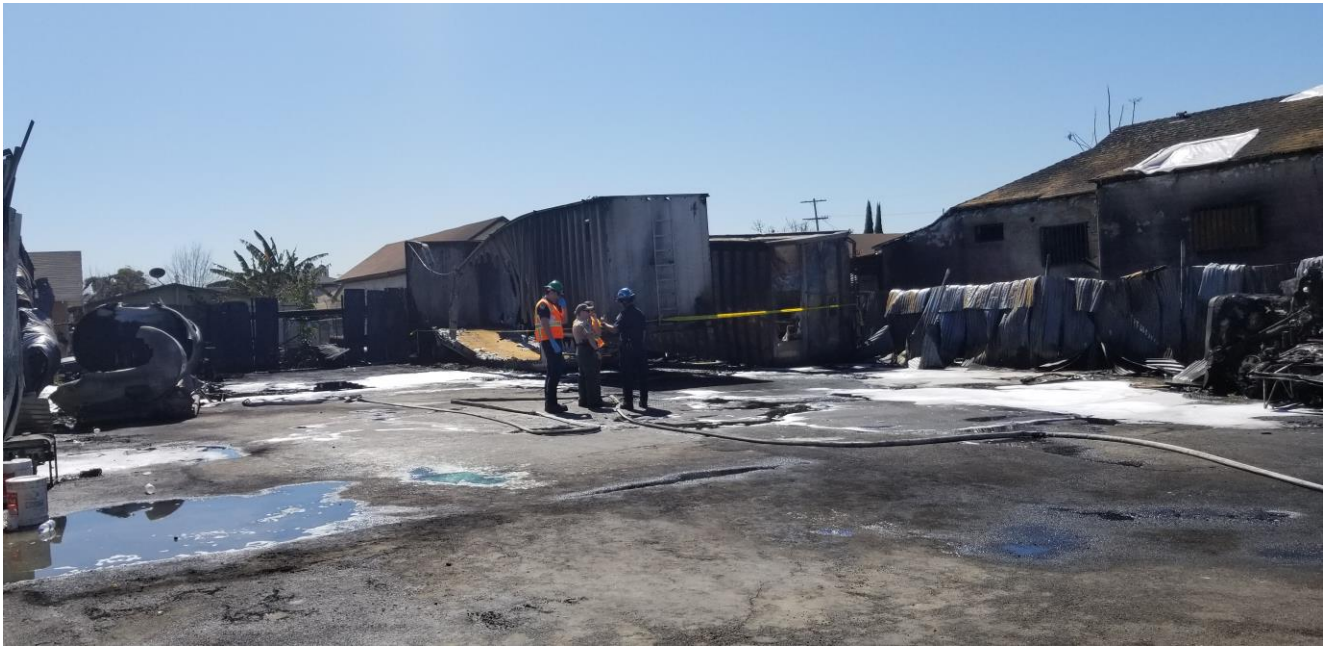
Figure #12.

View facing southwest at 210 W Slauson Ave, Parcel A, with fire-damaged “tanker,” two fire-damaged trailers, fire-damaged fencing, and fire-damaged home 216 W Slauson Ave. Ground pooling is likely a mixture of fuel, water and fire retardant.

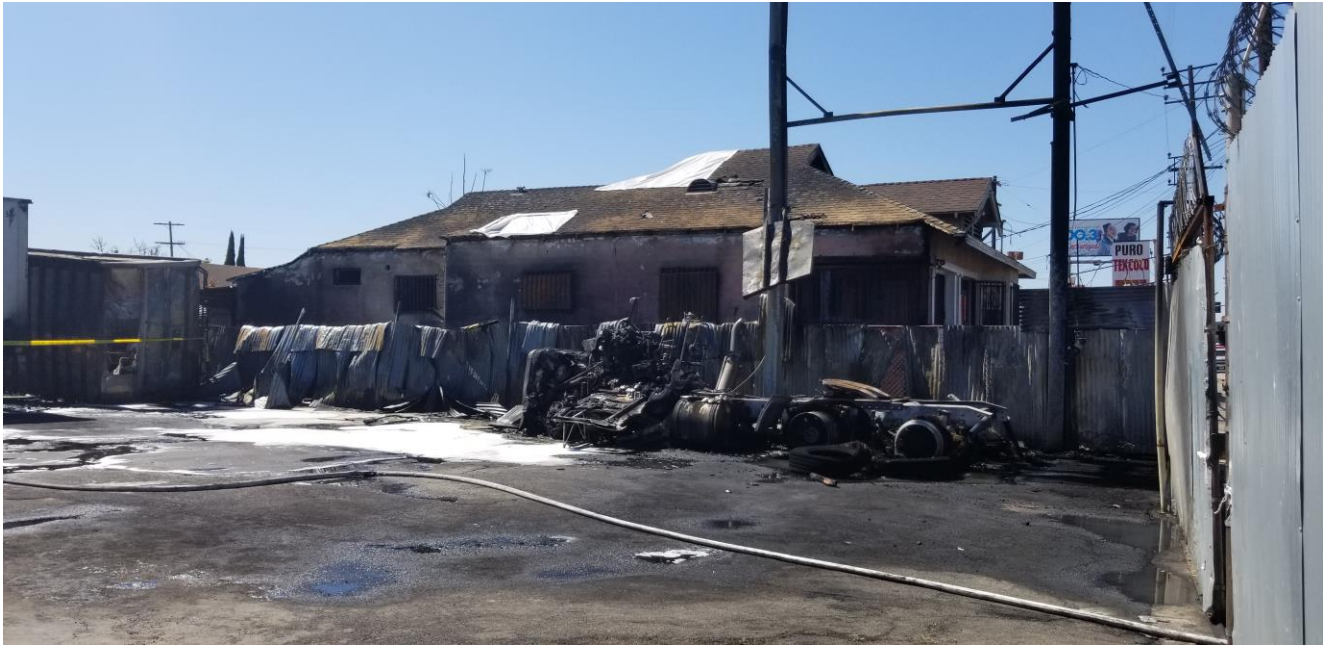
Figure #13.

View facing west at 210 W Slauson Ave, Parcel A, with fire-damaged fencing, fire-damaged vehicle, fire-damaged billboard supports, and fire-damaged home 216 W Slauson Ave. Ground pooling is likely a mixture of fuel, water and fire retardant.

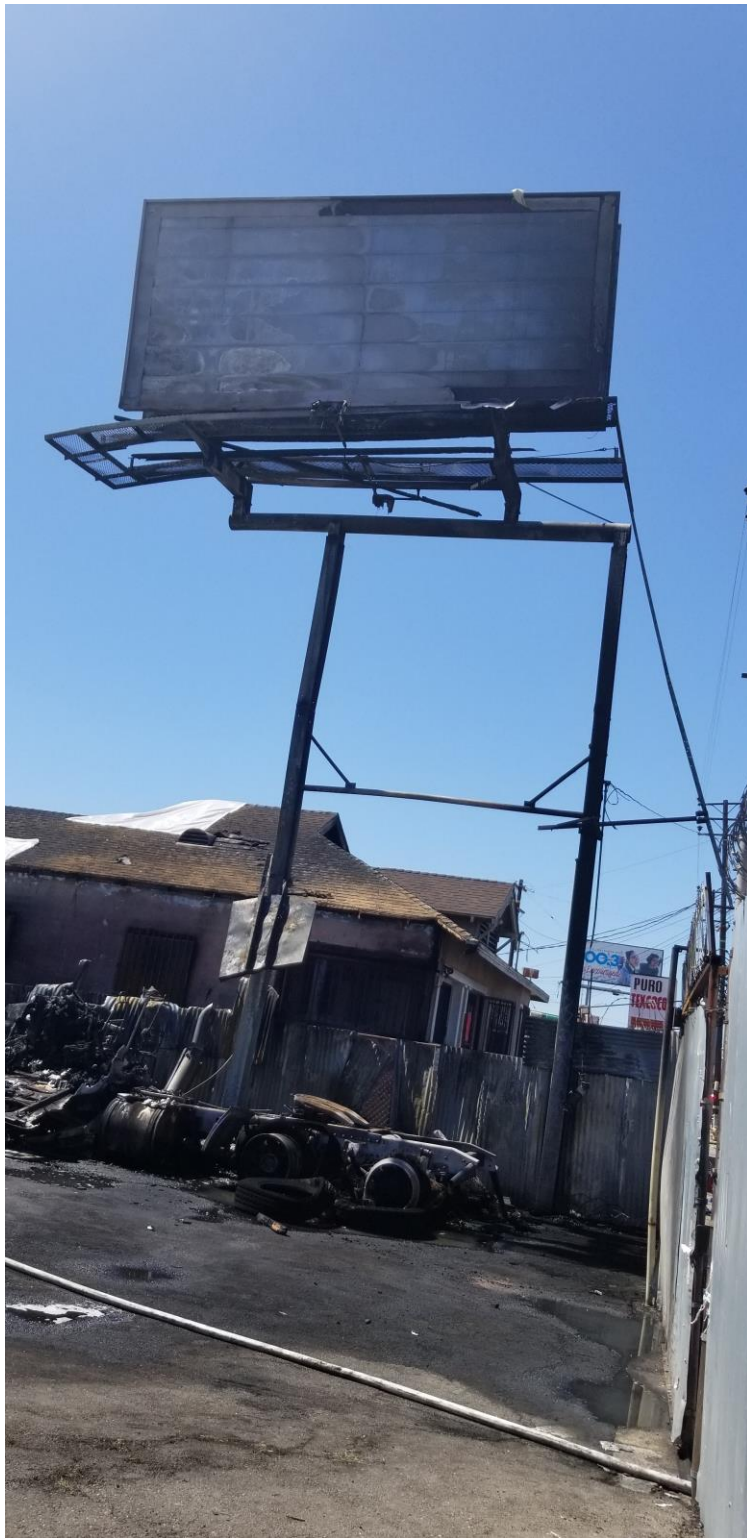
Figure #14.

View facing west at 210 W Slauson Ave, Parcel A, with fire-damaged fencing, fire-damaged vehicle, fire-damaged billboard, and fire-damaged home 216 W Slauson Ave. Ground pooling is likely a mixture of fuel, water and fire retardant.

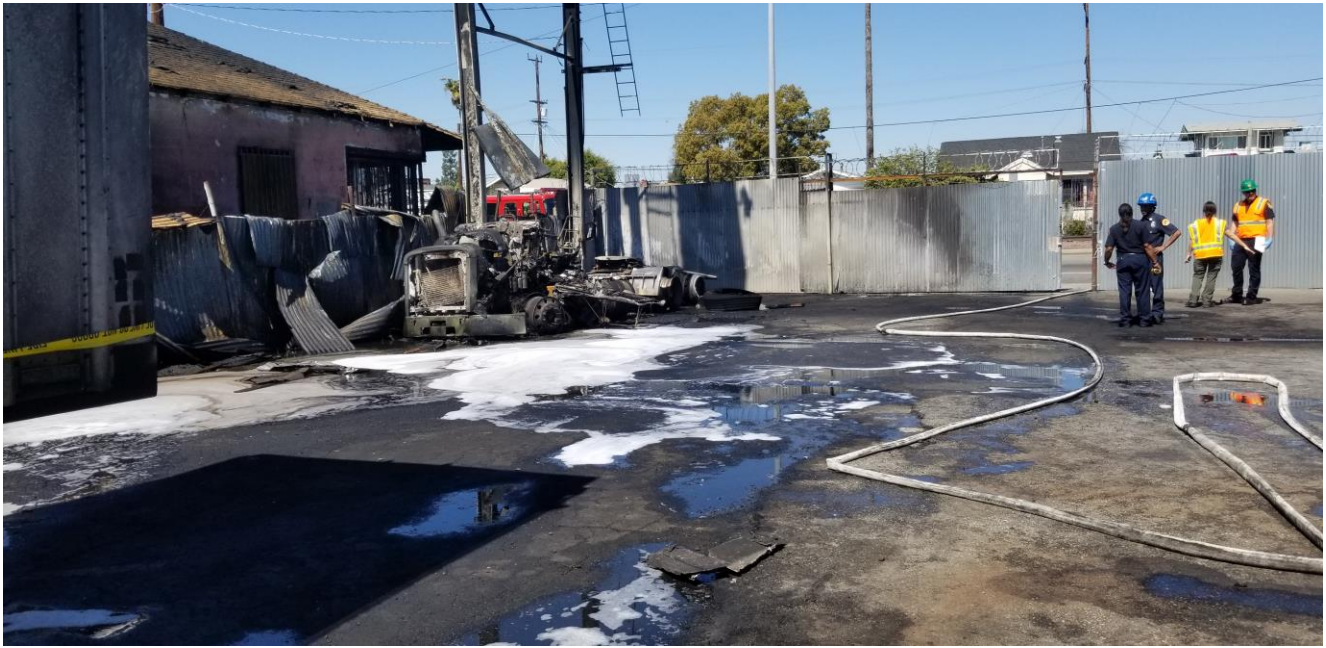
Figure #15.

View facing northwest at 210 W Slauson Ave, Parcel A, with fire-damaged fencing, fire-damaged vehicle, fire-damaged billboard supports, and fire-damaged home 216 W Slauson Ave. Ground pooling is likely a mixture of fuel, water and fire retardant.

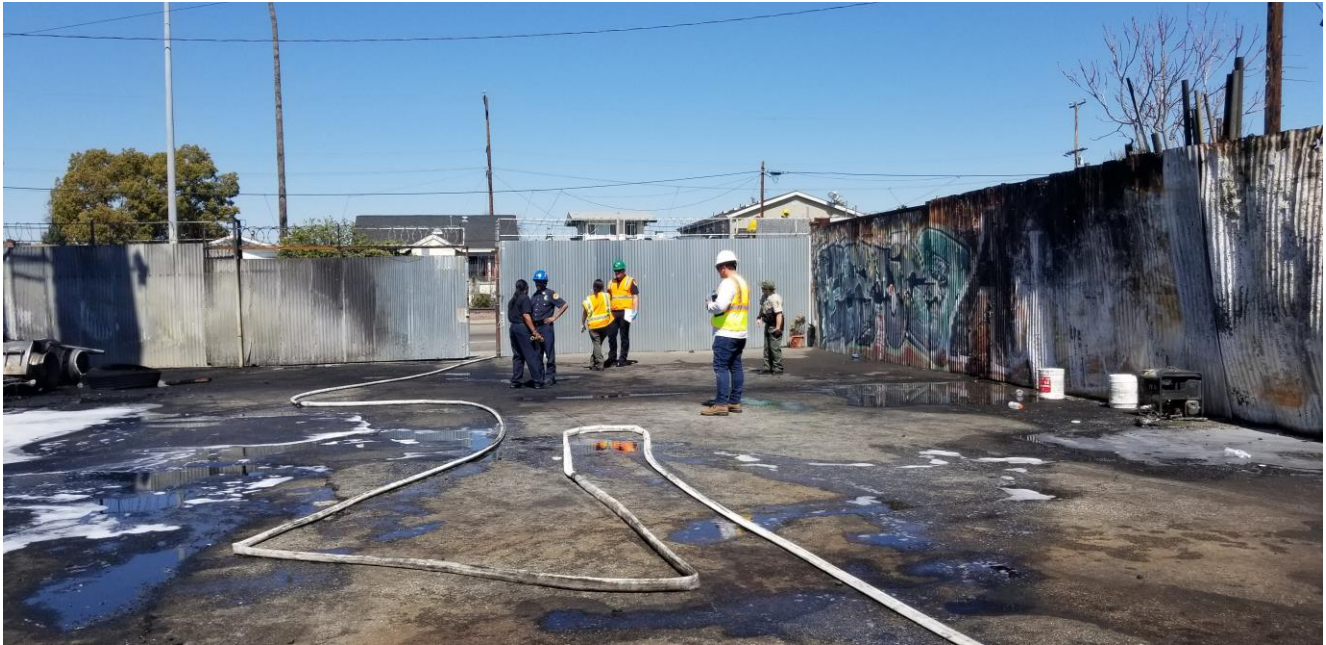
Figure #16.

View facing north at 210 W Slauson Ave, Parcel A, with fire-damaged fencing pictured. Ground pooling is likely a mixture of fuel, water and fire retardant.

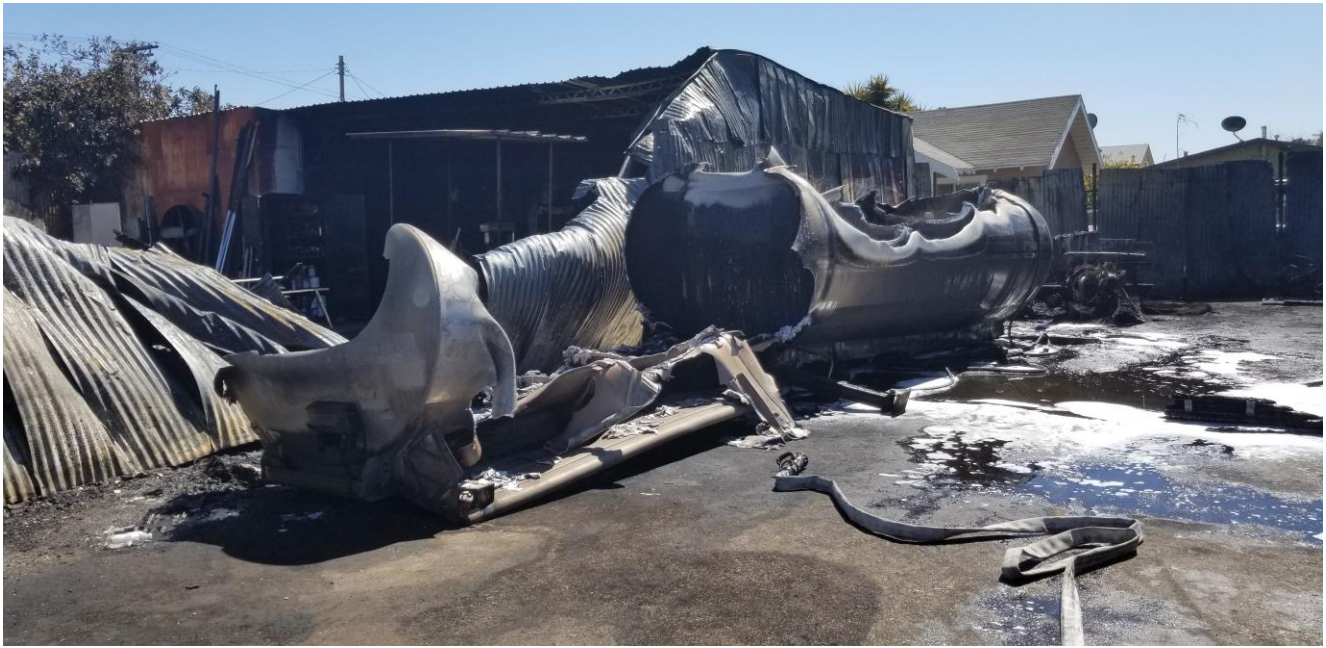
Figure #17.

View facing southeast at 210 W Slauson Ave, Parcel A, looking into Parcel B behind fire-damaged fencing. Entirety of fire-damaged “tanker” pictured. Ground pooling is likely a mixture of fuel, water and fire retardant.

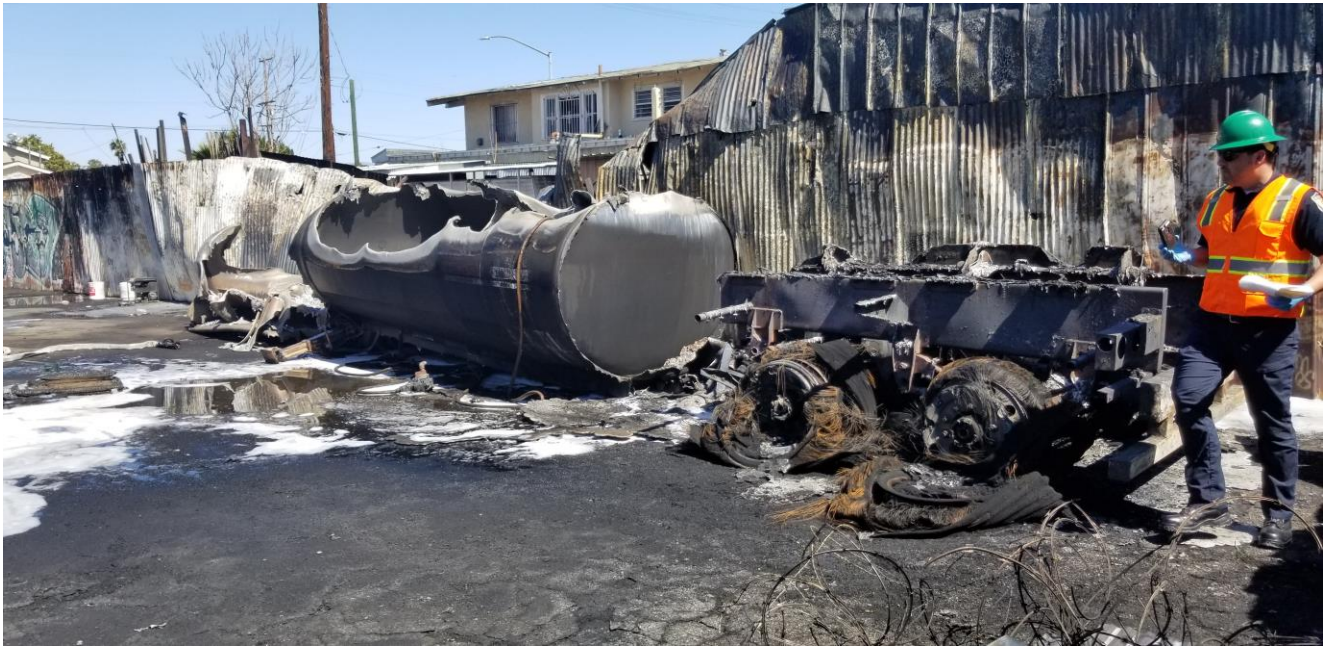
Figure #18.

View facing northeast at 210 W Slauson Ave, Parcel A, with fire-damaged “tanker” and fire-damaged wheels-and-axles component. Ground pooling is likely a mixture of fuel, water and fire retardant.

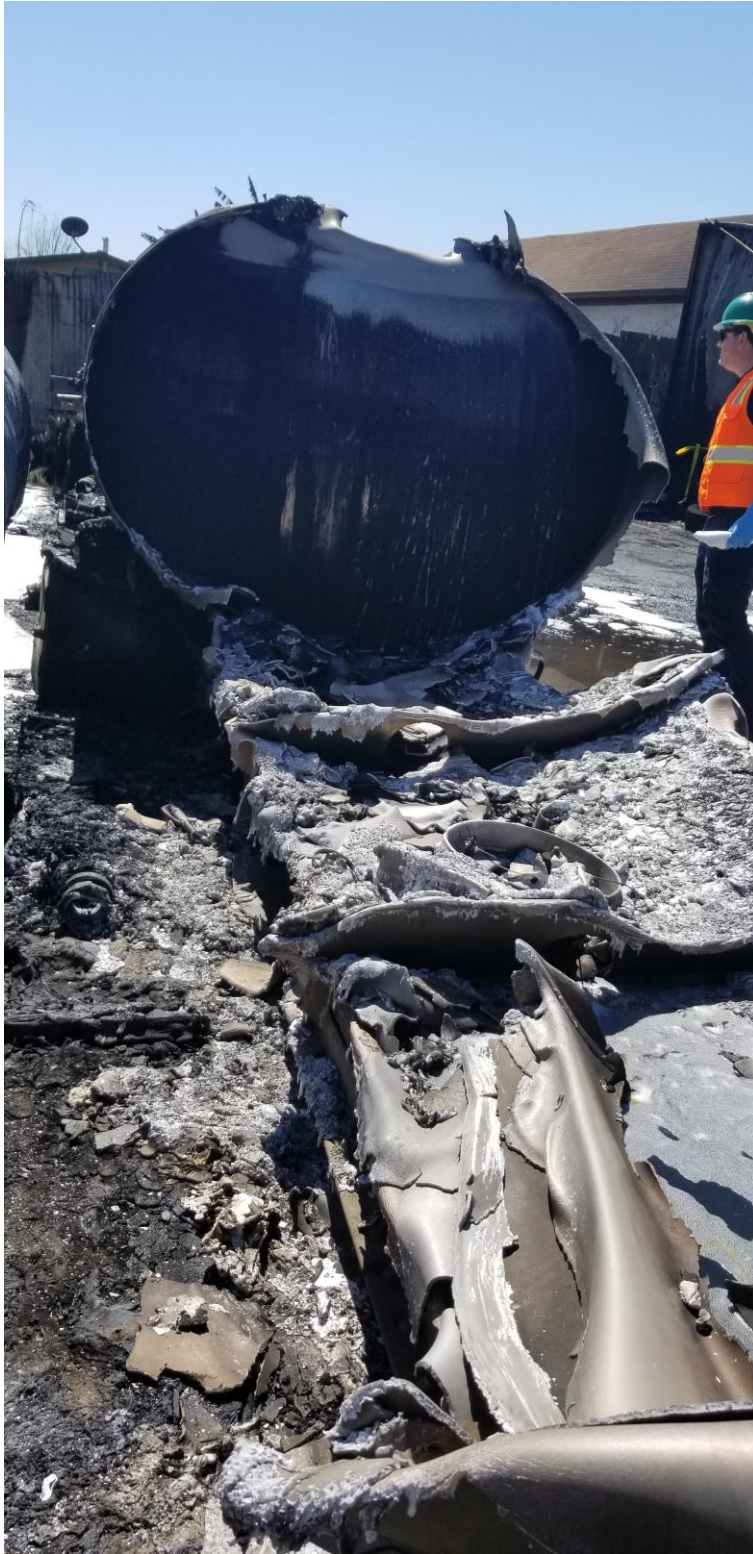
Figure #19.

View facing south at 210 W Slauson Ave, Parcel A. Front component of heavily fire-damaged “tanker” pictured.

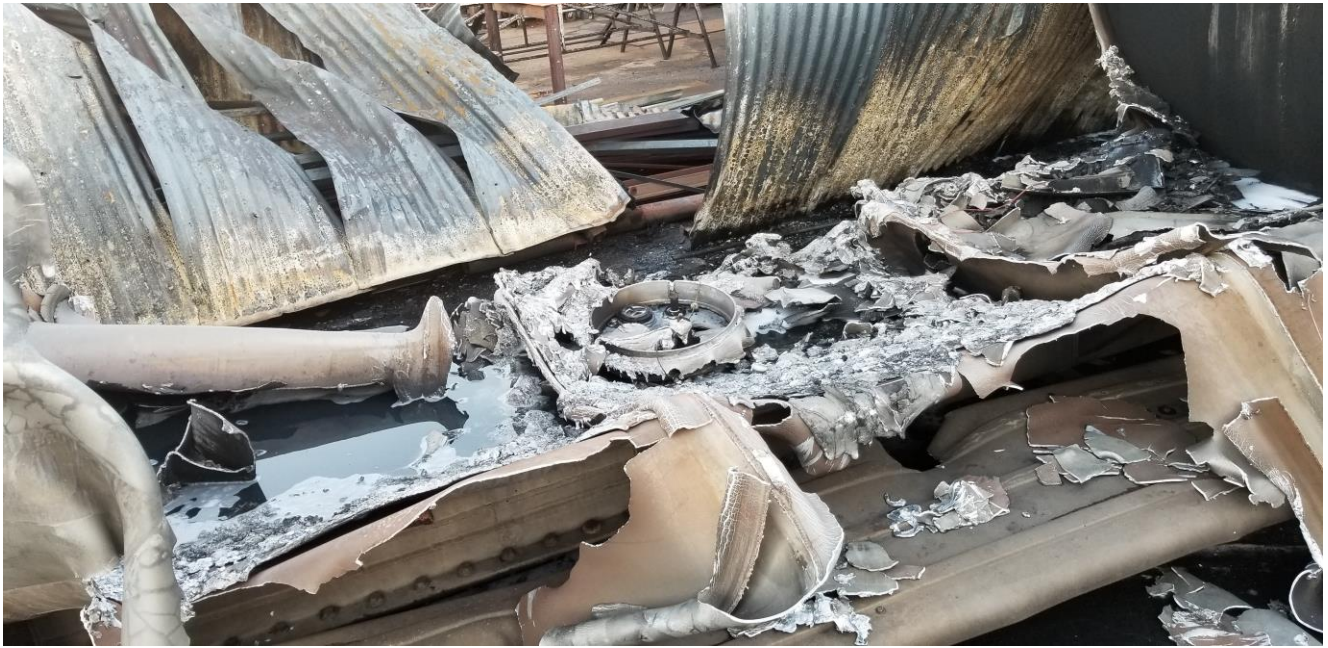
Figure #20.

View facing southeast at 210 W Slauson Ave, Parcel A. Front component of heavily fire-damaged “tanker” with likely a mixture of fuel, water and fire retardant inside. Fire-damaged fencing pictured in background.

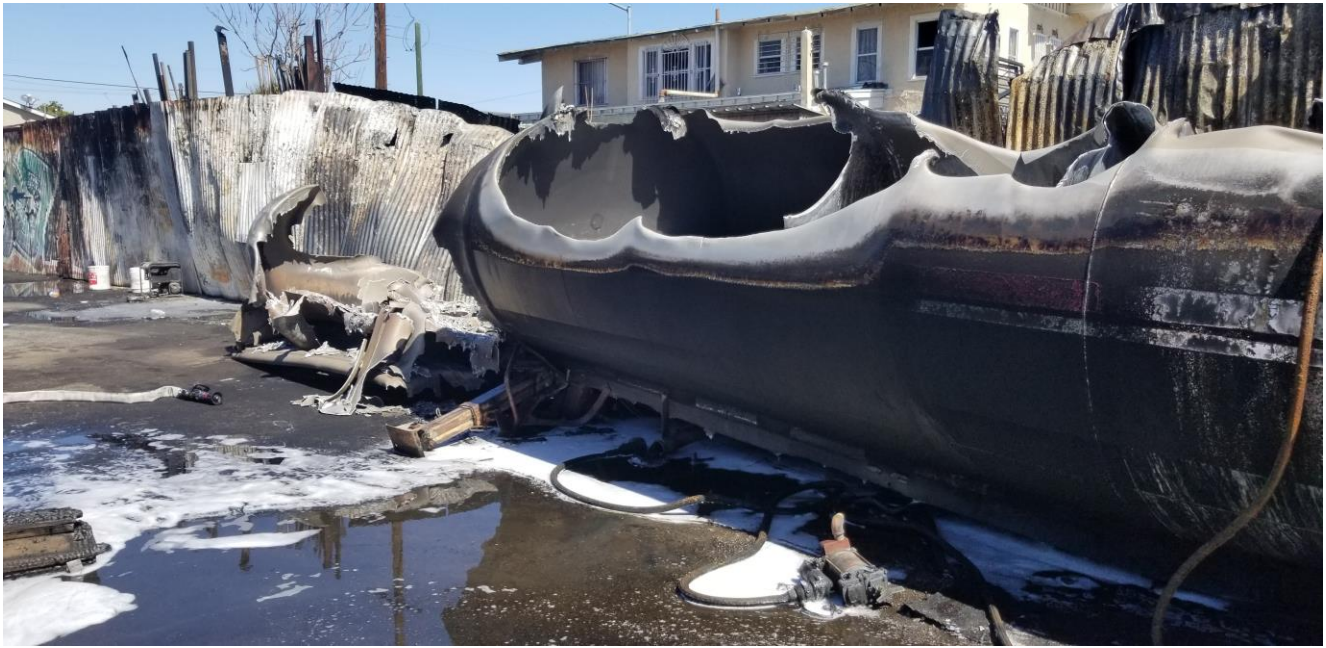
Figure #21.

View facing northeast at 210 W Slauson Ave, Parcel A. Side view of fire-damaged “tanker.” Ground pooling is likely a mixture of fuel, water and fire retardant. Fire-damaged fencing pictured in background.

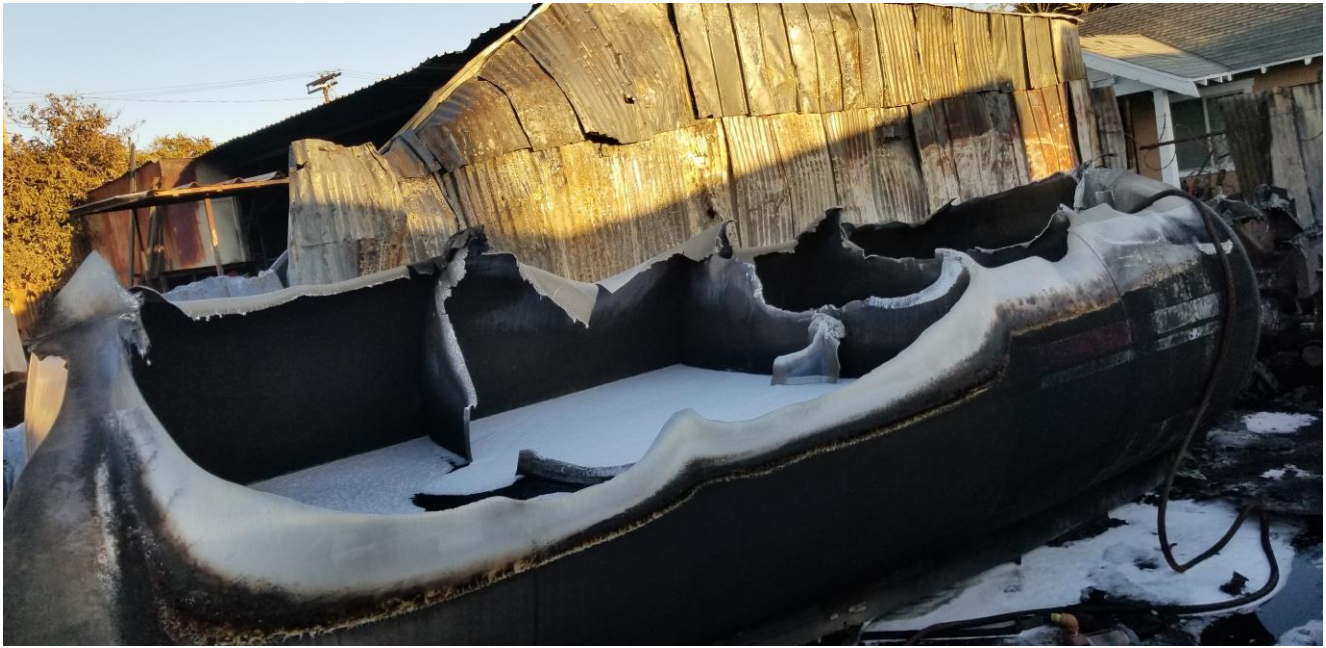
Figure #22.

View facing southeast at 210 W Slauson Ave, Parcel A. Side view of fire-damaged “tanker” with fuel and fire retardant inside.

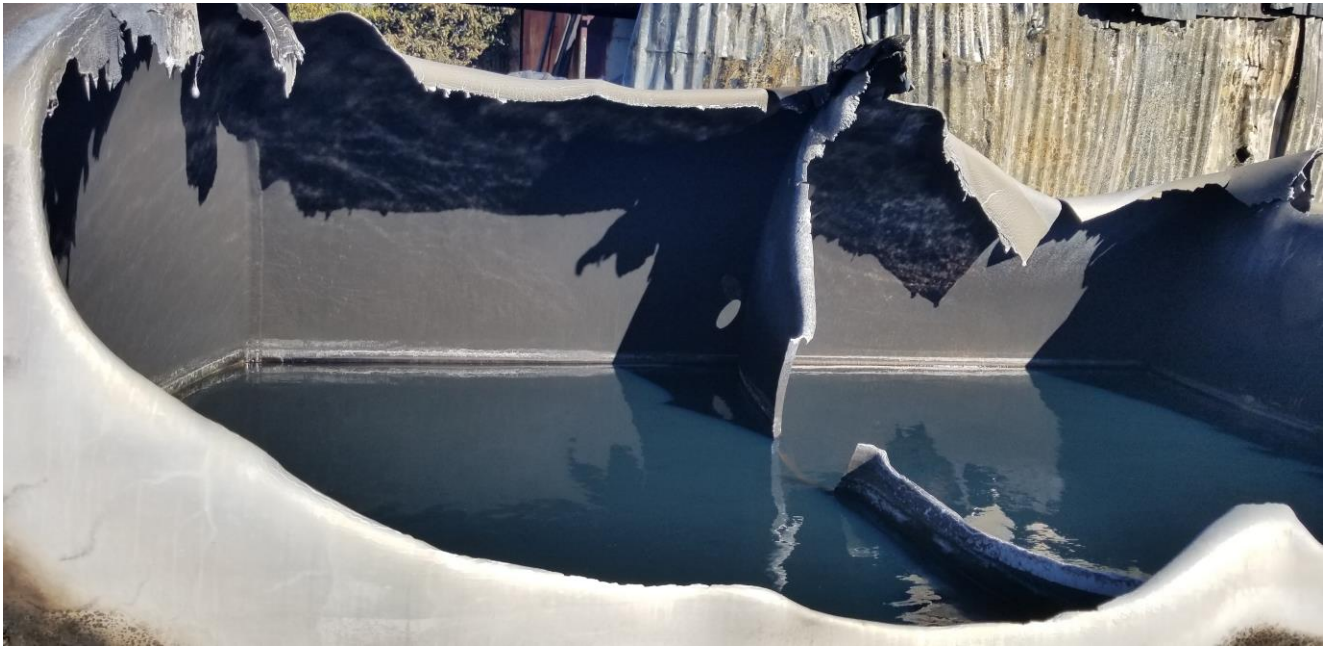
Figure #23.

View facing east at 210 W Slauson Ave, Parcel A. Close-up view inside of fire-damaged “tanker.”

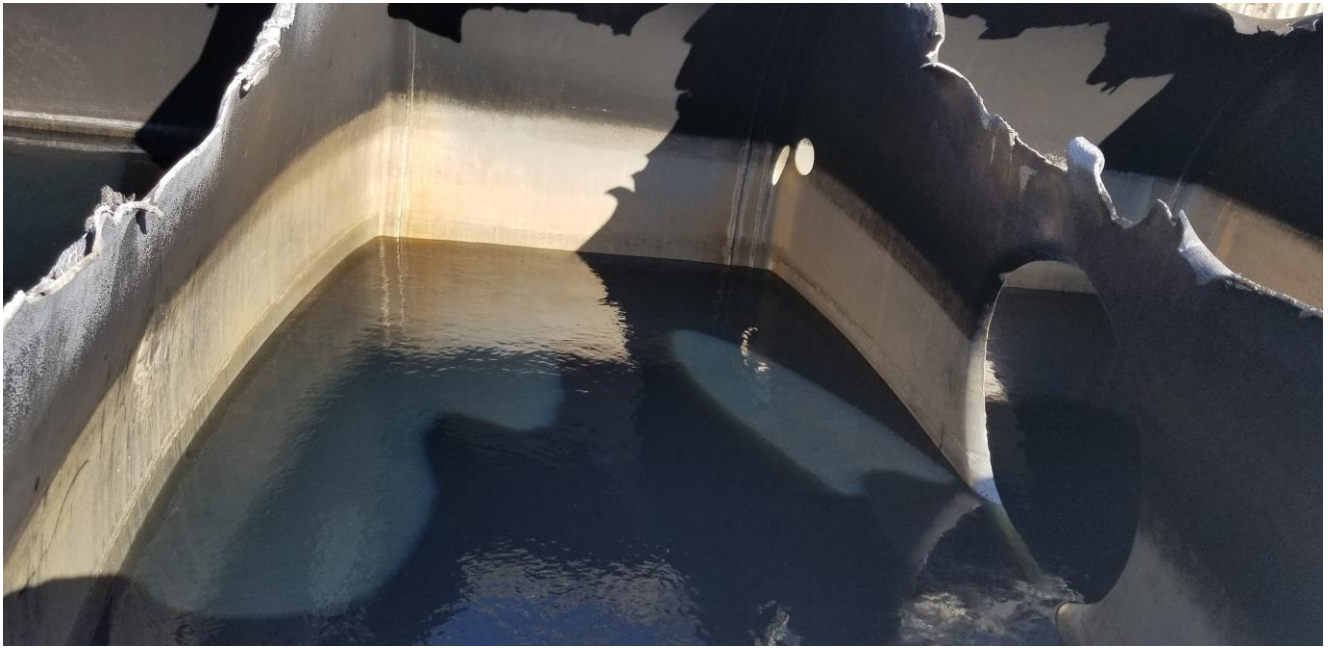
Figure #24.

Downward view inside of fire-damaged “tanker” on 210 W Slauson Ave, Parcel A.

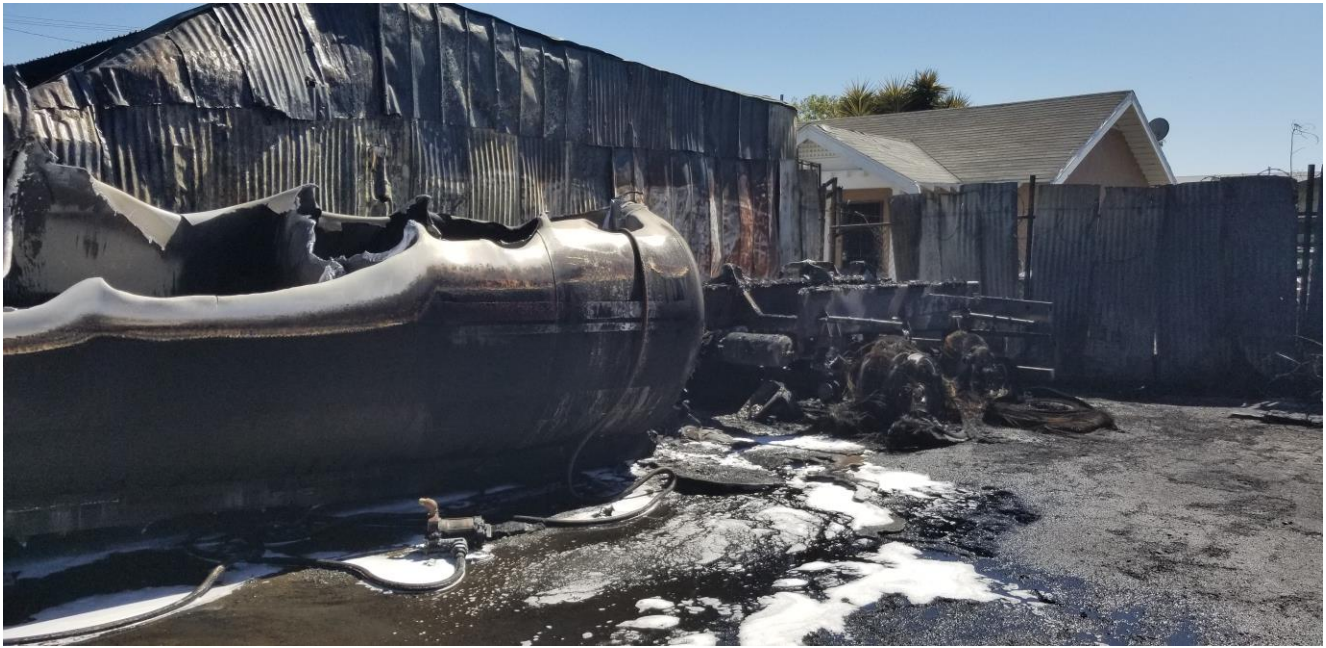
Figure #26.

View facing southeast at 210 W Slauson Ave, Parcel A, with fire-damaged “tanker” and fire-damaged wheels-and-axles component. Ground pooling is likely a mixture of fuel, water and fire retardant.

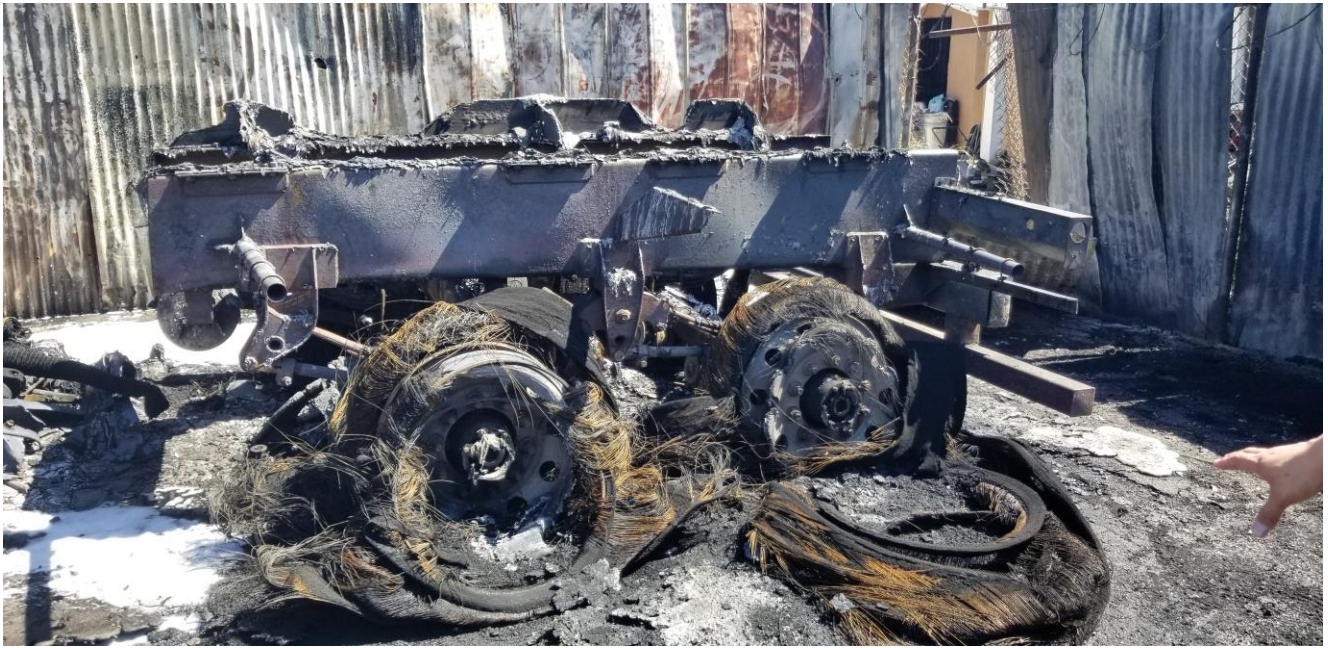
Figure #27.

View facing east at 210 W Slauson Ave, Parcel A, with fire-damaged wheels-and-axles component.

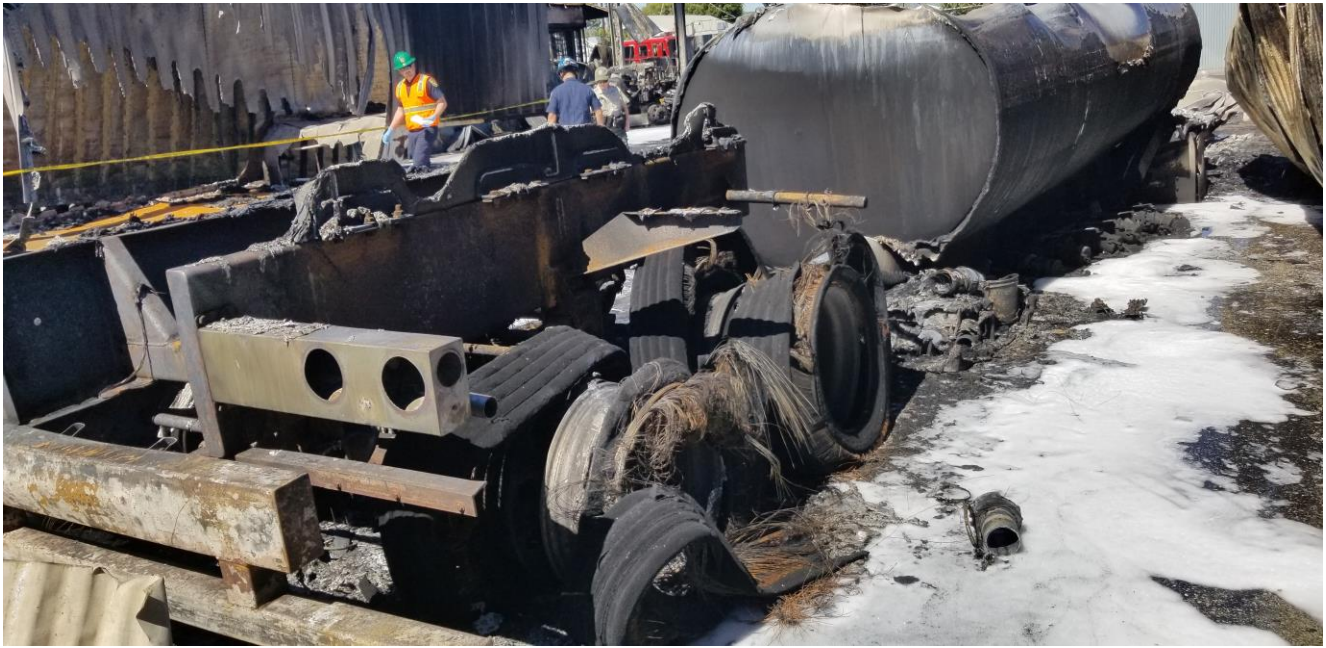
Figure #28.

View facing northwest at 210 W Slauson Ave, Parcel A, with fire-damaged wheels-and-axles component and fire-damaged “tanker.” Ground pooling likely a mixture of fuel, water and fire retardant.

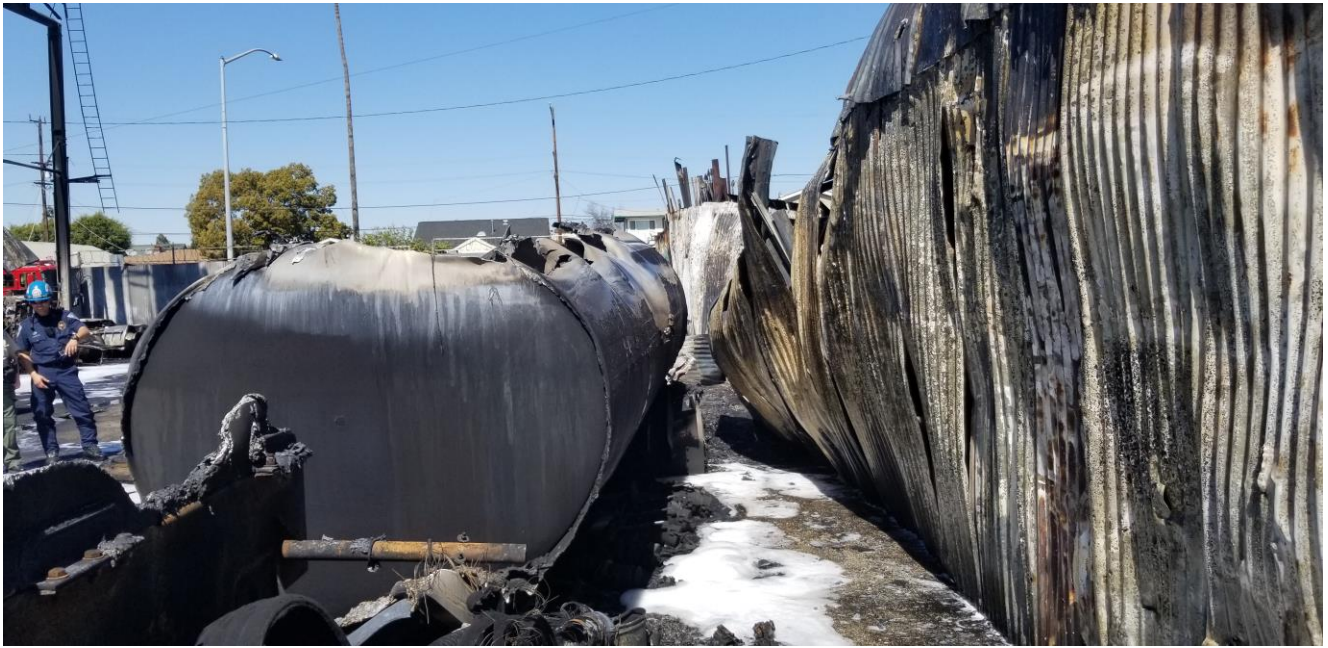
Figure #29.

View facing north at 210 W Slauson Ave, Parcel A, with fire-damaged “tanker” and fire-damaged fencing separating Parcel A from Parcel B. Ground pooling likely a mixture of fuel, water and fire retardant.

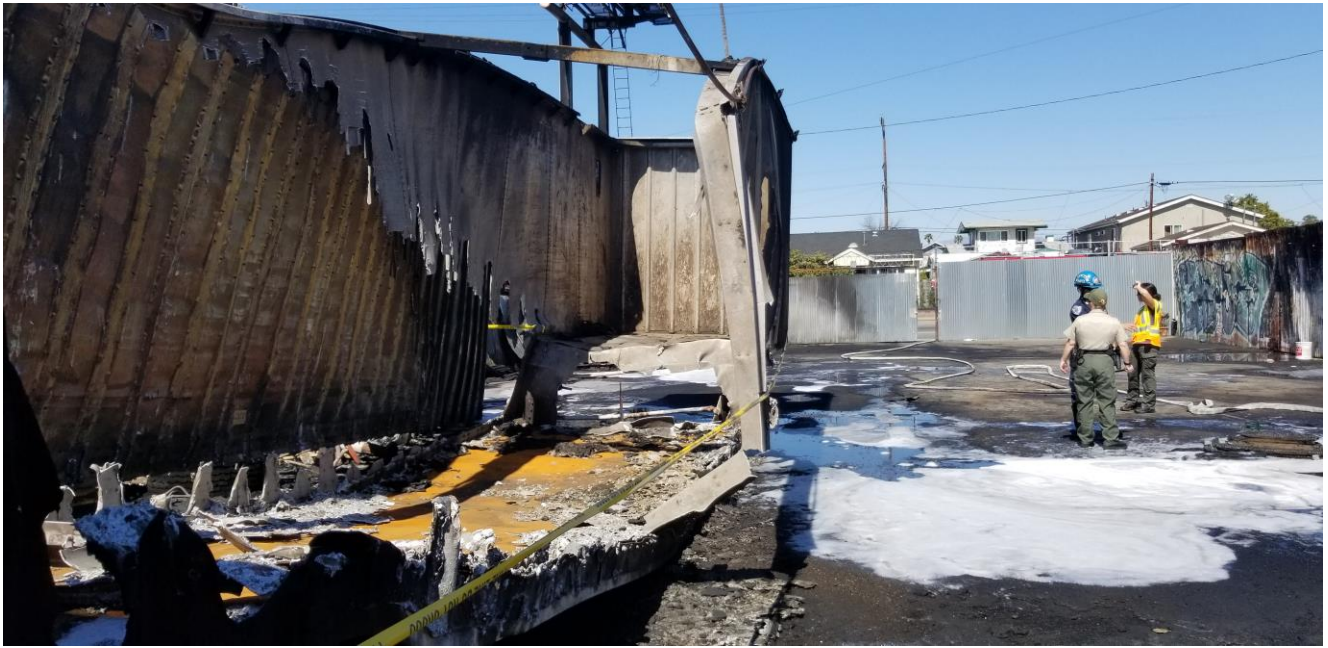
Figure #30.

View facing north at 210 W Slauson Ave, Parcel A, with a fire-damaged trailer. Ground pooling likely a mixture of fuel, water and fire retardant.
